GEOTECHNICAL INVESTIGATION

PAUL HOBBS IRRIGATION RESERVOIR
11835 POCKET CANYON ROAD
GUERNEVILLE, CALIFORNIA

11993.1

December 28, 2006

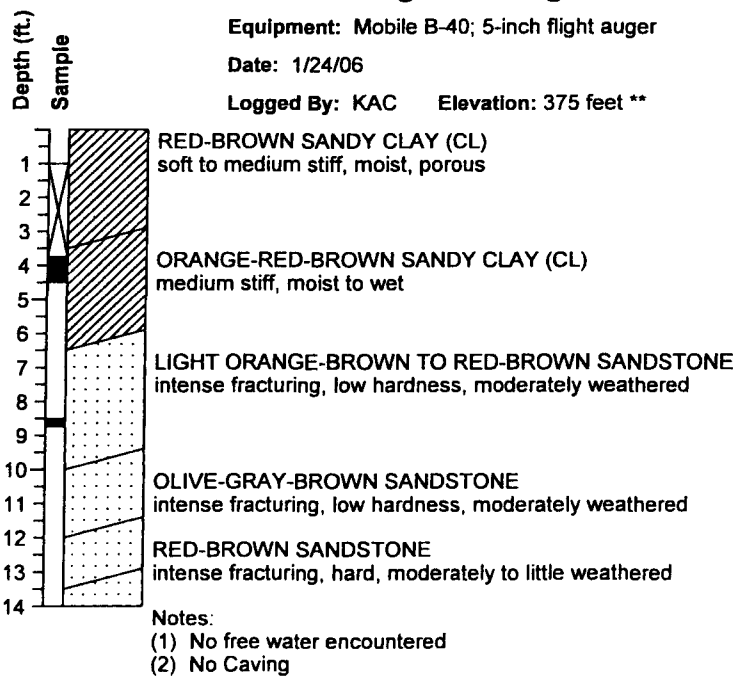
Log of Boring B-4

Equipment: Mobile B-40; 5-inch flight auger

Date: 1/24/06

Logged By: KAC Elevation: 375 feet **

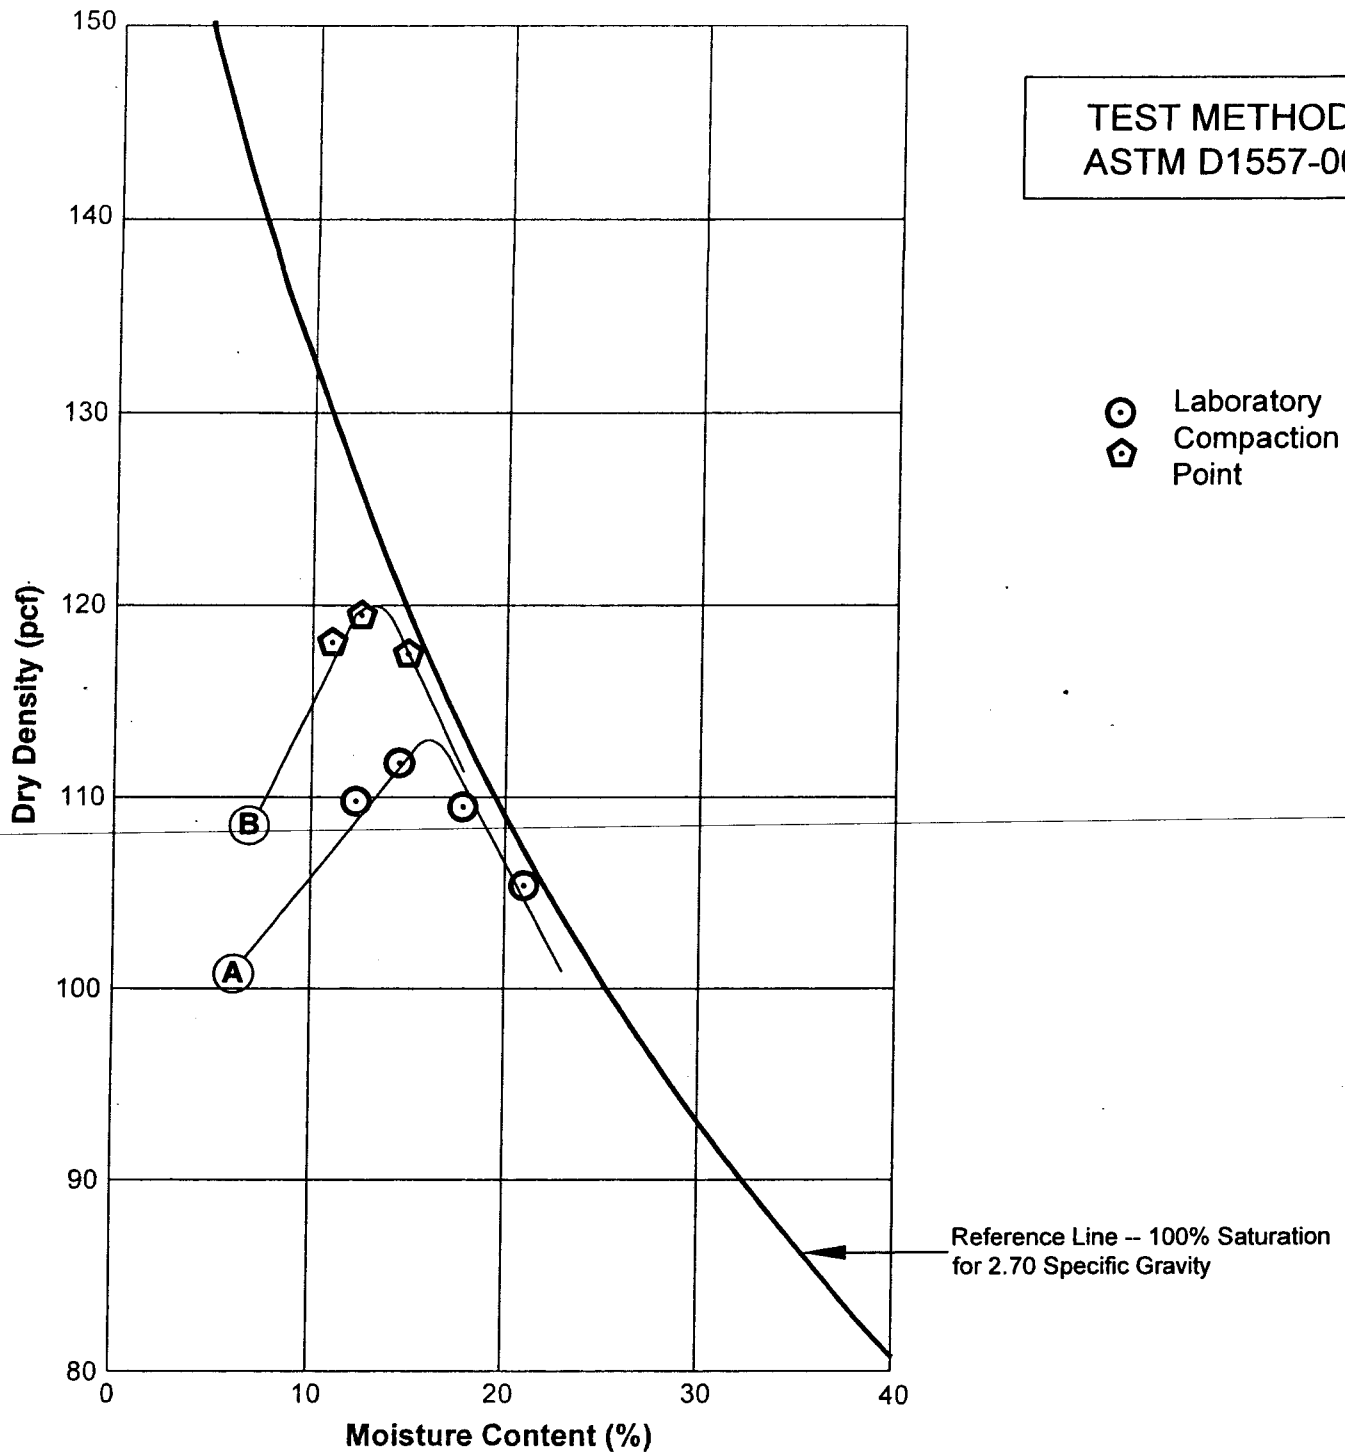
TEST METHOD
ASTM D1557-00

Symbol	Sample Source	Classification	Optimum Moisture (%)	Maximum Dry Density (pcf)
○ A	Boring B-4 at 1-4 feet	RED-BROWN CLAYEY SAND (SC)	16.0	113
◡ B	Boring B-2 at 3-6.5 feet	LIGHT ORANGE-BROWN SANDSTONE	13.5	120

Selected samples were tested in our laboratory to determine their pertinent geotechnical engineering characteristics. Laboratory testing consisted of moisture content/dry density, maximum dry density (compaction), classification (No. 200 sieve), and remolded permeability (triaxial cell). Compaction test data and the permeability test results are presented on Plates 8 and 9, respectively.

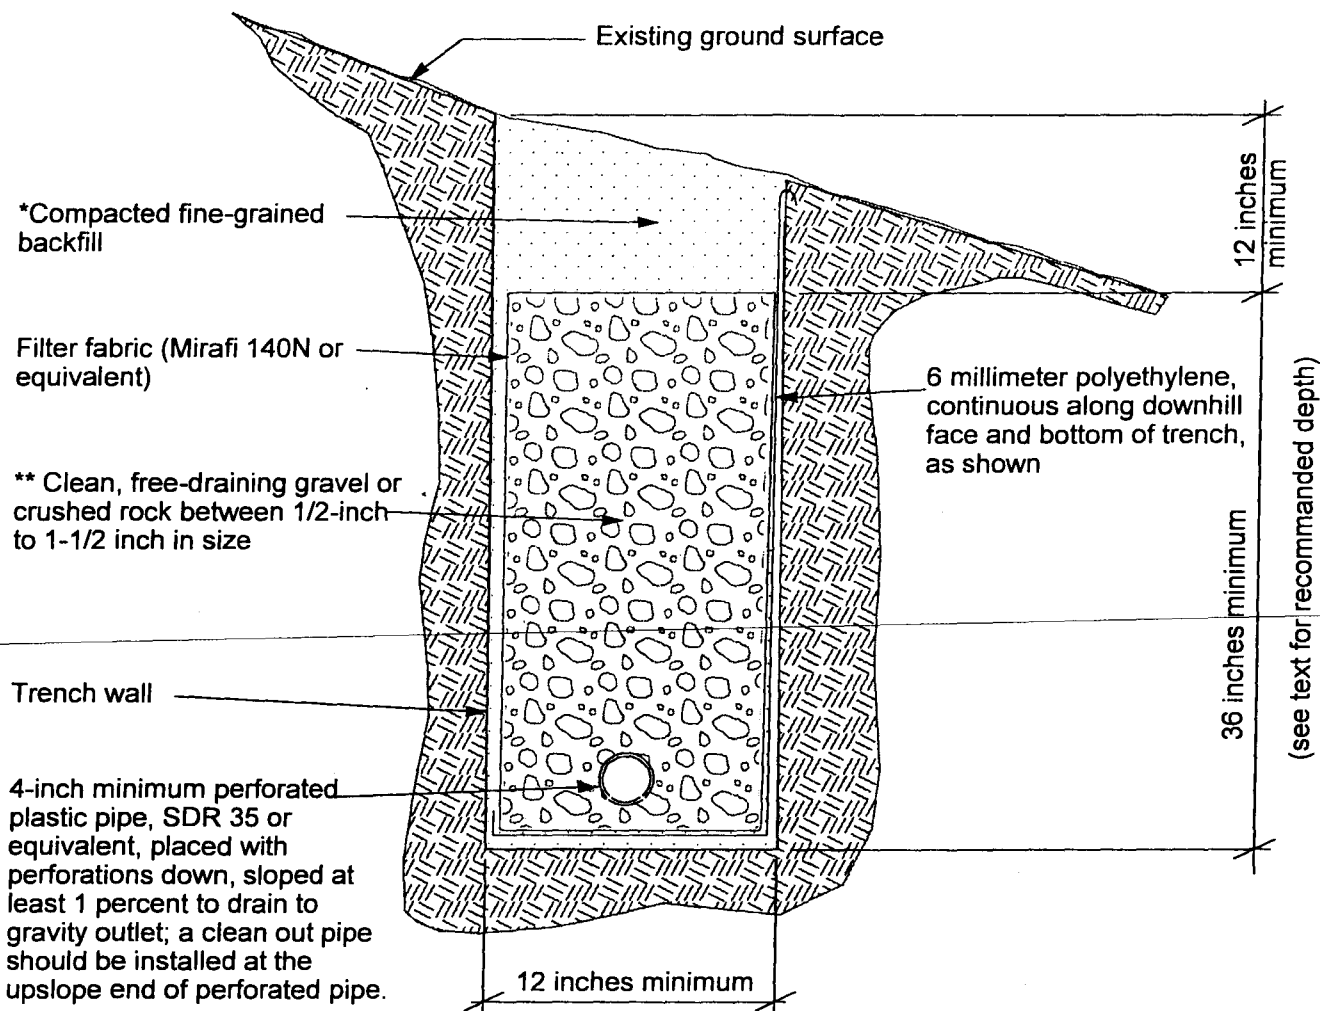
PLATE
10

**TYPICAL SECTION
NO SCALE**

* 90 percent relative compaction minimum in accordance with ASTM D 1557 Test Method, latest edition.

The subdrain should be constructed in accordance with the Keyway Drainage Detail, Plate 10.
